### STUDIES OF SETTLEMENT AND SEEPAGE AT CLARK HILL DAM DURING AND AFTER CONSTRUCTION

by Frank M. Bell

## STUDIES OF SETTLEMENT AND SEEPAGE AT CLARK HILL DAM DURING AND AFTER CONSTRUCTION

Frank M. Bell, Assoc. M. ASCE  
Chief Soil Mechanics Br.,  
So. Atlantic Div. Laboratory, Corps of Engrs.,  
U. S. Army, Marietta, Georgia

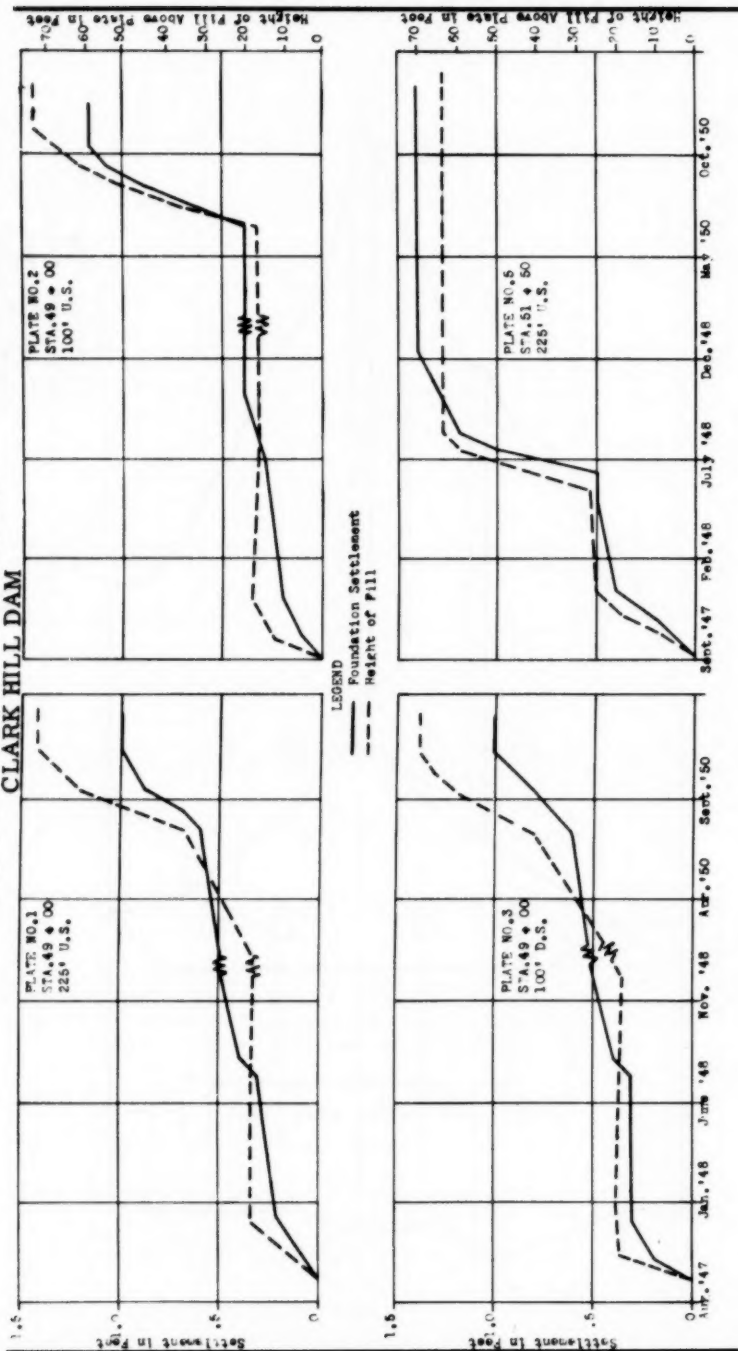
Fig. 3-FOUNDATION SETTLEMENT  
CLARK HILL DAM

The riser on plate 4 was damaged in the early stages of construction. The action of the remainder is shown in figures 3 and 4. The pattern of all is similar. The observations confirmed predictions with respect to both rate and magnitude of settlement.

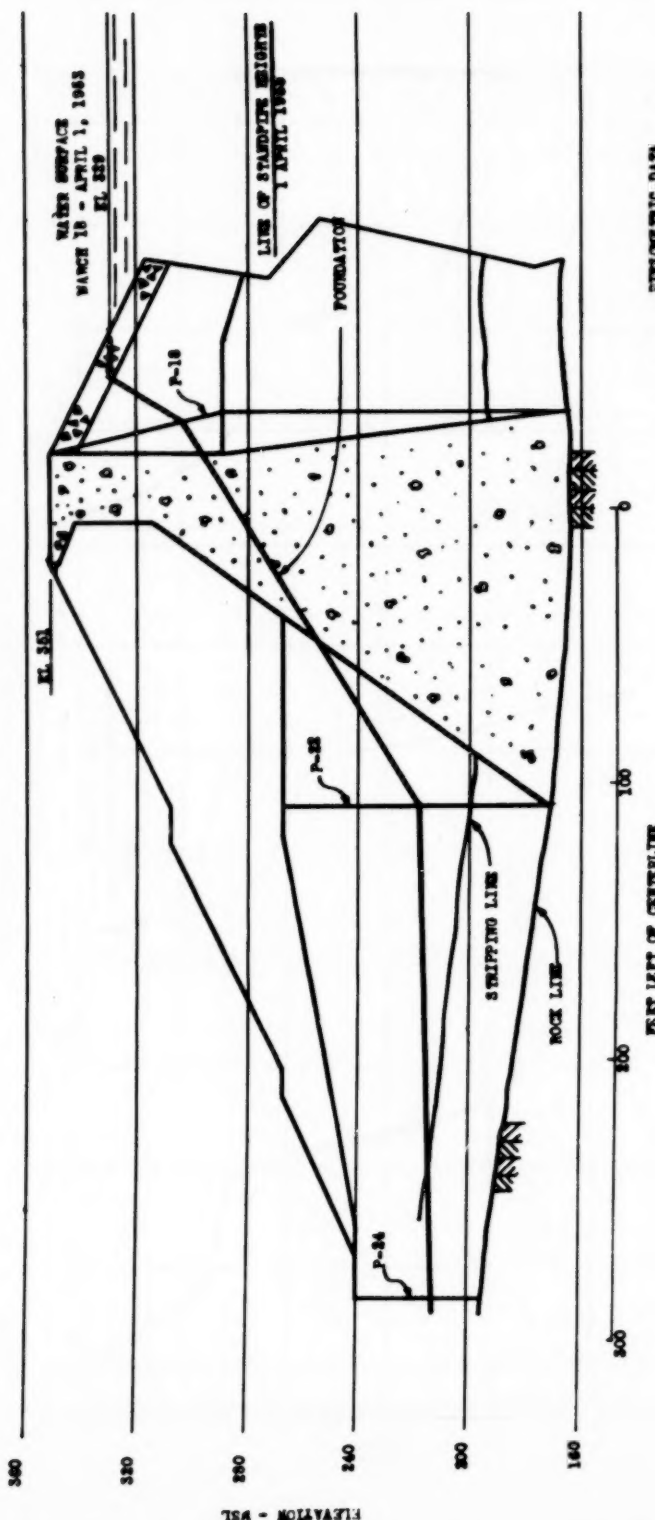
PERMANENT DATA  
STATION 45 + 90 - CLARK HILL DAM

Figure 5 shows the line of standpipe heights along the rock line at the junction of the concrete and earth sections. This indicates that the cut-off measures are operating effectively. The fact that the line is brought up to the intersection of the water surface and the dam may be misleading. This portion of the line is probably much flatter than shown on the drawing, intersecting the water surface further upstream. These remarks also apply to the founda-

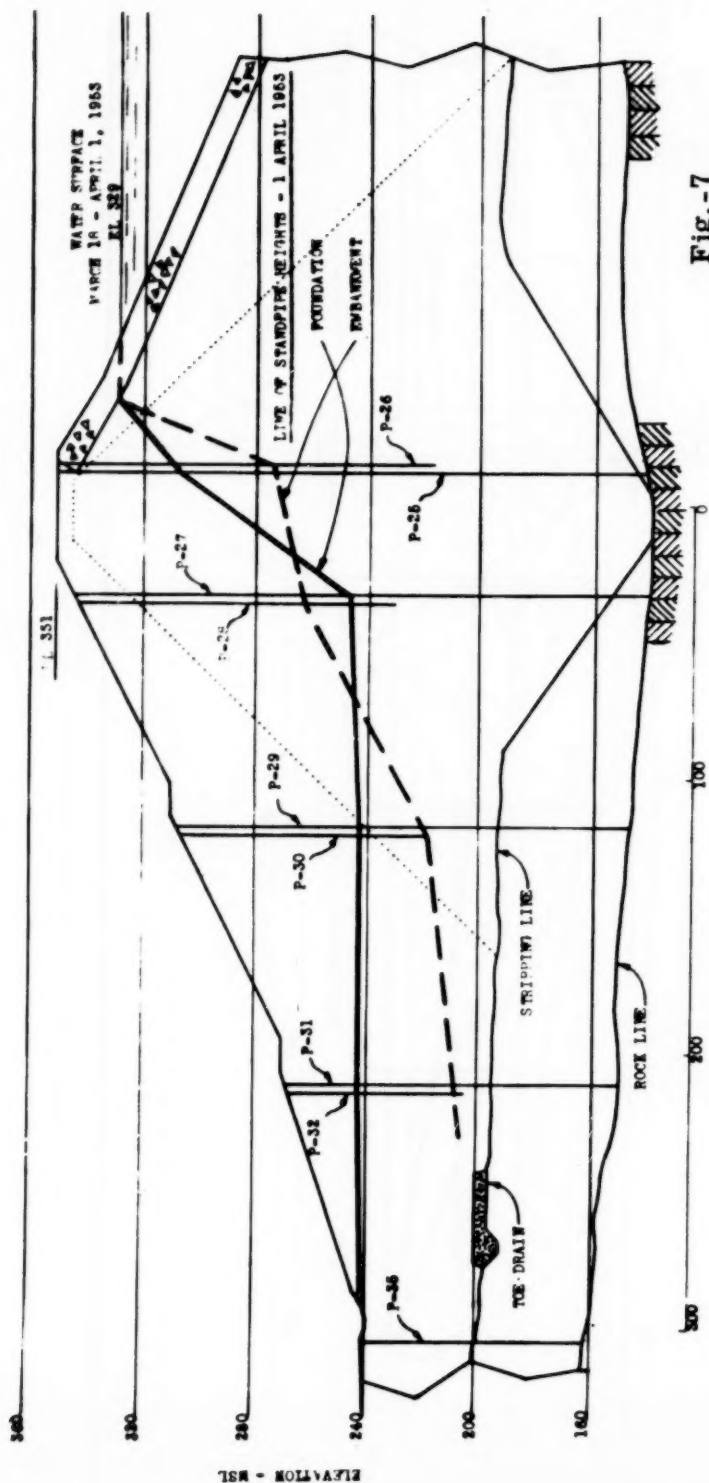
**Fig.-7**  
PIEZOMETRIC DATA  
STATION 61 + 60 - CLARK HILL DAM

Figure 7 shows results of observations in the flood plain at the location of the filled channel previously described. These indicate that adequate head loss occurs in the embankment and the toe drain is functioning effectively. The hydrostatic head in the downstream portion of the foundation, however is somewhat higher than had been anticipated.

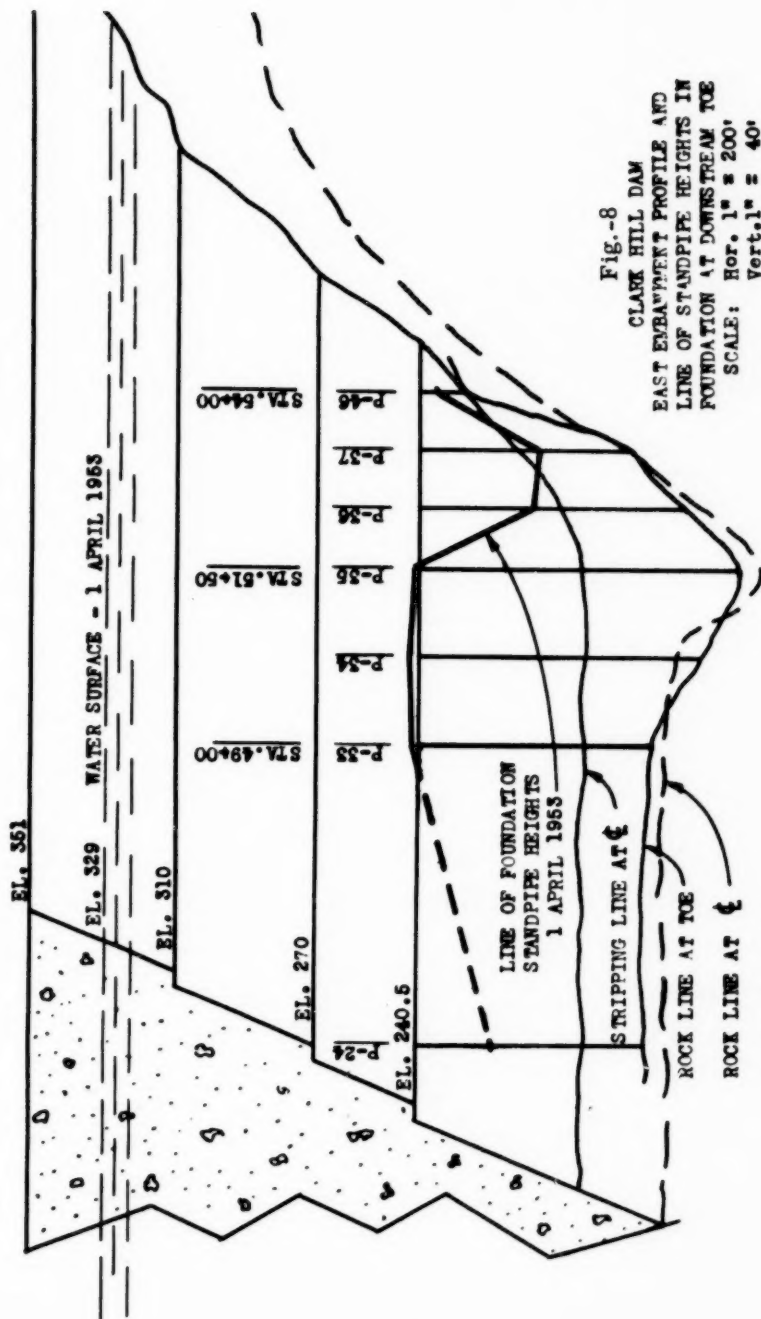
Fig.-8  
CLARK HILL DAM  
EAST ELEVATION PROFILE AND  
LINE OF STANDPIPE HEIGHTS IN  
FOUNDATION AT DOWNSTREAM TOE  
SCALE: Hor. 1" = 200'  
Vert. 1" = 40'

Figure 8 shows the line of standpipe heights along the rock line at the downstream toe of the main dam superimposed on the profile of the foundation along the axis of the dam. The area of relatively high pressures lies between stations 49 + 00 and 51 + 50. It will be remembered that the top 20 feet of the foundation is quite impervious. This artesian condition may be caused by an underlying continuous stratum of highly pervious soils or by fissures in the rock or both. No abnormal seepage conditions may be observed at the toe of the switchyard fill.
